TruShape™ Roll Analysis for Roll 1210.5828

Concerning: Roll Geometry Inspection for New Cover & Grind Produced by [name removed]

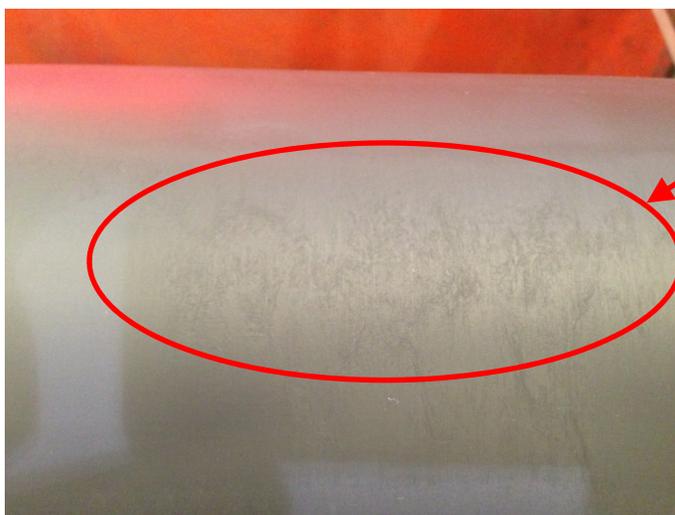
Before performing the TruShape™ inspection, the inspector wiped down the entire surface of the roll to check for any surface irregularities. Immediately, the surface finish stood out as a problem. Marble-like formations were visible throughout the entire surface. This phenomenon is usually attributed to layers of a calendar build process that have not properly knit together in the vulcanization process. The marbled patches not only were visible but also consisted of texture differences.

MARBLE-LIKE FORMATIONS VISIBLE ON ROLL SERVICE, USUALLY DUE TO IMPROPER CALENDAR BUILD AND VULCANIZATION.

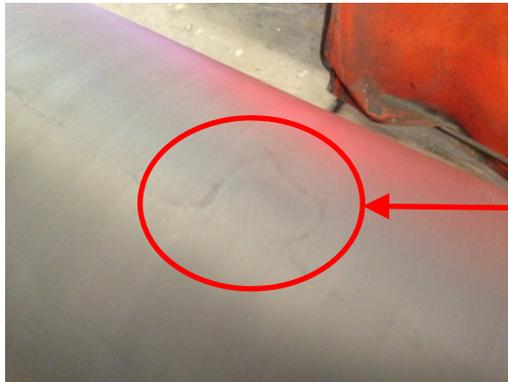
AIR POCKET LOCATION

While wiping the surface, the inspector also discovered two large air pockets in the cover. These bubbles of trapped air below the surface move differently than the rest of the cover usually leading to process issues with the web.

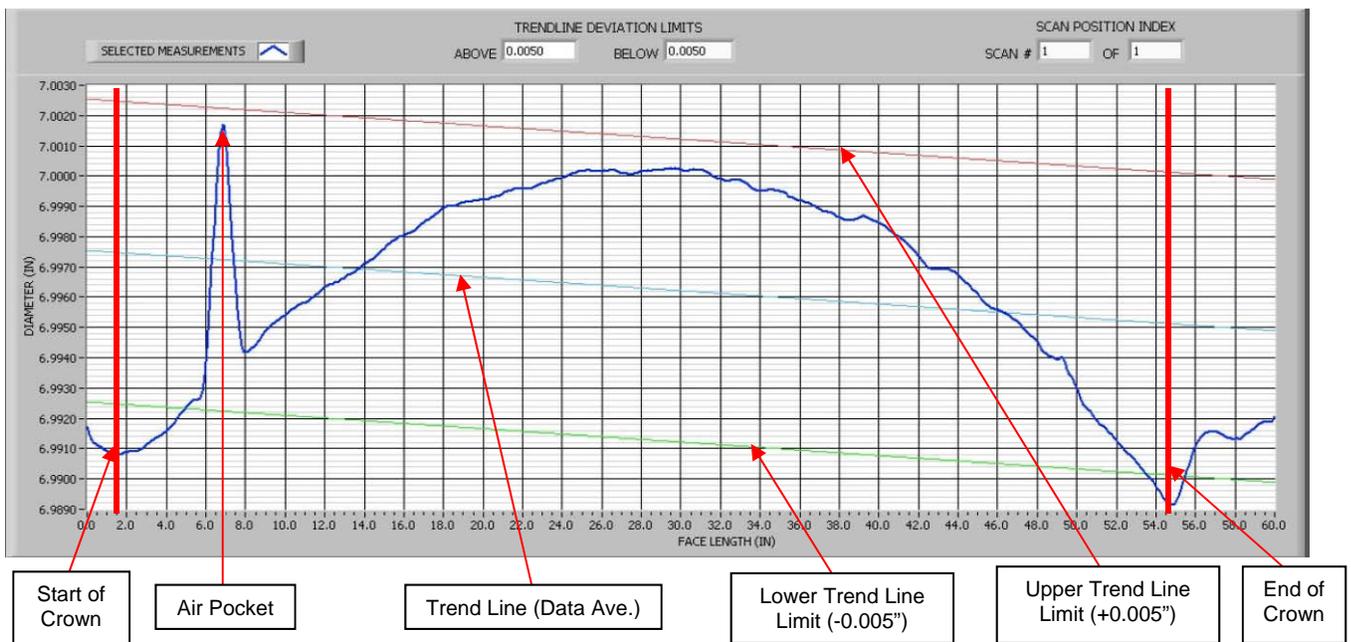
At first glance, the crown looks good. However, upon closer inspection, a large peak at about 7 inches in from the start is visible. This peak coincided with the large air cell that was discovered. Other points worth mentioning include an overall taper in the shape of 0.003", a crown start at nearly 2 inches from the leading edge of the roll, and a crown end at about 3.5 inches from the end of the roll with a "gutter" occurring at 54.5" that could lead to uneven squeegeeing.
